SUBJECT: Operational Report - Lessons Learned, Headquarters, 19th Engineer Battalion (Combat)(Army), Period Ending 31 October 1968

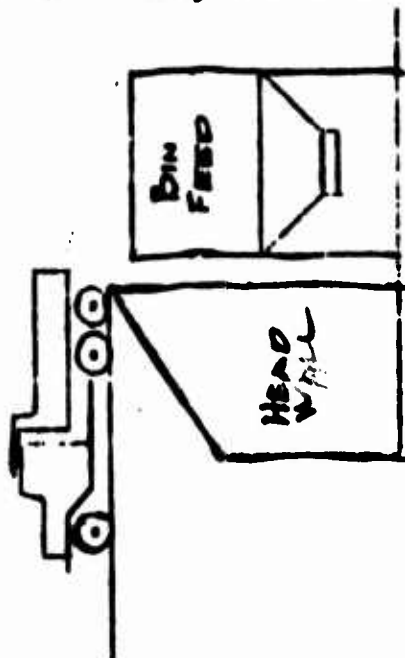
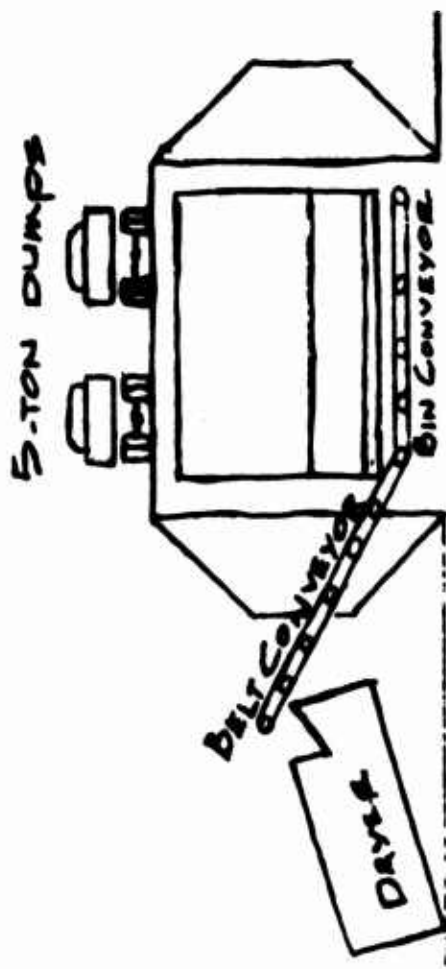
SIDE VIEW OF
BIN FEED UNIT

DRAWN NOT TO SCALE

Bin Feed Unit On 150 TPH Asphalt Plant
